Airlines ordered to reduce ice risk

Ice is suspected of having caused the crash in December of a SAS MD-80 jetliner in Sweden. The FAA* has ordered airlines flying these aircraft to adopt new safety procedures

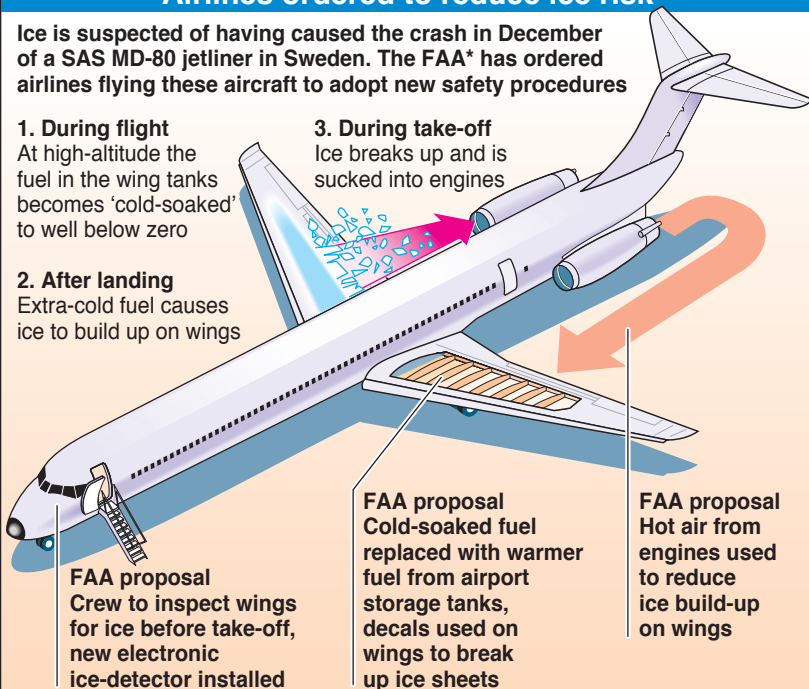
1. During flight

At high-altitude the fuel in the wing tanks becomes 'cold-soaked' to well below zero

2. After landing

Extra-cold fuel causes ice to build up on wings

3. During take-off

Ice breaks up and is sucked into engines

FAA proposal
Crew to inspect wings for ice before take-off, new electronic ice-detector installed

FAA proposal
Cold-soaked fuel replaced with warmer fuel from airport storage tanks, decals used on wings to break up ice sheets

FAA proposal
Hot air from engines used to reduce ice build-up on wings
