# F-35 Lightning II glitch list

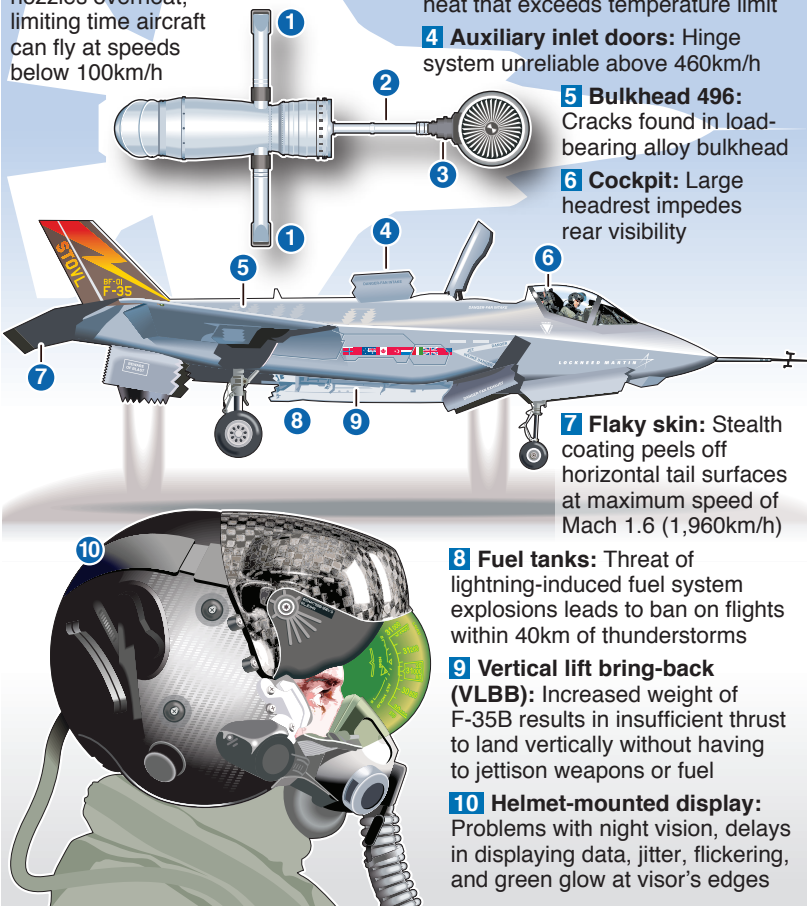
**1 Roll port nozzles:** F-35B jump-jet uses engine bleed air to control roll during low speed and hover. Actuators in wings that rotate nozzles overheat, limiting time aircraft can fly at speeds below 100km/h

**2 Driveshaft:** Unacceptable levels of compression and expansion

**3 Lift-fan clutch:** Clutch plates touch – friction generates excessive heat that exceeds temperature limit

**4 Auxiliary inlet doors:** Hinge system unreliable above 460km/h

**5 Bulkhead 496:** Cracks found in load-bearing alloy bulkhead

**6 Cockpit:** Large headrest impedes rear visibility

**7 Flaky skin:** Stealth coating peels off horizontal tail surfaces at maximum speed of Mach 1.6 (1,960km/h)

**8 Fuel tanks:** Threat of lightning-induced fuel system explosions leads to ban on flights within 40km of thunderstorms

**9 Vertical lift bring-back (VLBB):** Increased weight of F-35B results in insufficient thrust to land vertically without having to jettison weapons or fuel

**10 Helmet-mounted display:** Problems with night vision, delays in displaying data, jitter, flickering, and green glow at visor's edges
