Report says MH17 downed by outside impacts

Malaysia Airlines Flight 17 was likely struck by multiple “high-energy objects from outside the aircraft,” causing it to break up over eastern Ukraine, according to a preliminary report by Dutch investigators

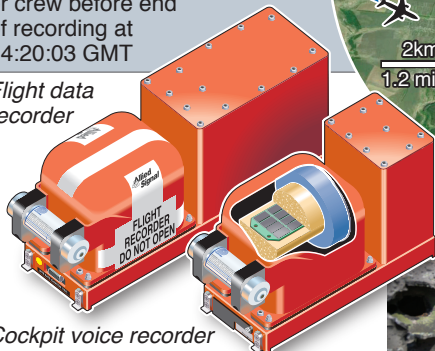
Flight data recorder

No evidence of manipulation. No indications of technical or operational issues with aircraft or crew before end of recording at 14:20:03 GMT

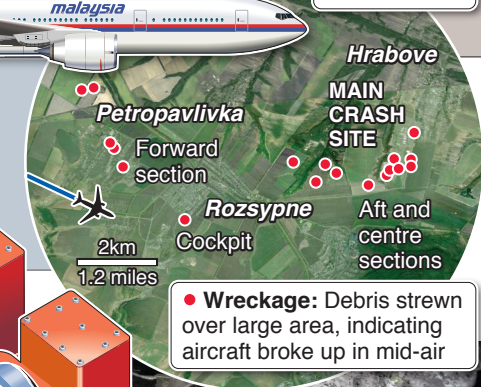
● **Wreckage:** Debris strewn over large area, indicating aircraft broke up in mid-air

■ **Damage:** Forward section appears to show high-velocity impacts from outside aircraft. Evidence could be consistent with plane being hit by shrapnel from missile
