Possible structure defect in collapsed condo

Structural engineers think critical concrete supporting structures at the collapsed Champlain Towers South condominium may not have had enough internal reinforced steel bars, known as “rebar”

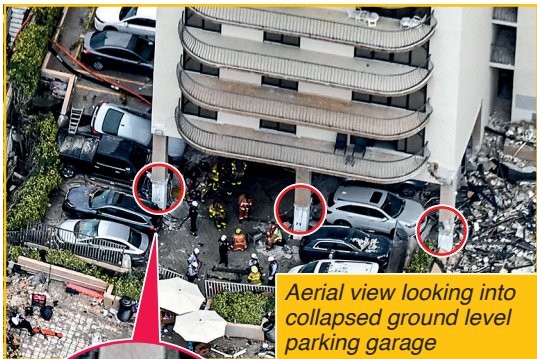
Aerial view looking into collapsed ground level parking garage

Collapsed deck exposes areas where rebar is used to connect three pillars to concrete floor. Photos indicate **two** or **three** rods sticking out of each pillar's face

Two rods per face would mean **four** bars passing through each column

1979: Original plans stipulate **eight** bars should pass through each column
