Rescue of New Zealand miners delayed

PIKE RIVER MINE
Opened 2008

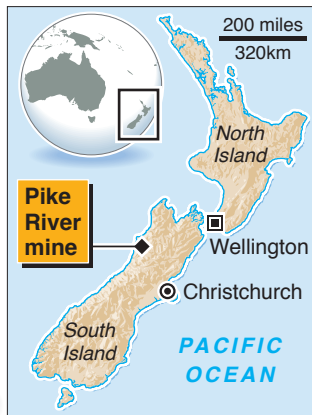
First robot, sent down tunnel to search for survivors, shorted out when it was hit by water falling from roof of mine.
Second remote device to be deployed

Robot equipped with cameras and sensors to test for toxic fumes. Will relay information to rescuers by fibre-optic cable
