Fukushima nuclear plant status report

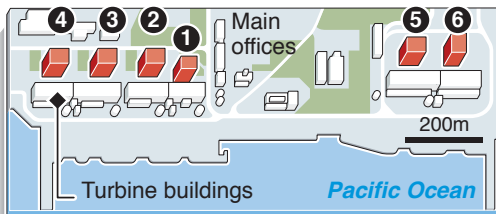
Reactor 1: Explosion on March 12 blows top off reactor building

Reactor core: Possible partial meltdown. Primary containment vessel intact. Radioactive iodine-131 found in seawater discharge

Reactor 2: Explosion on March 15 breaches primary containment and torus

Reactor core: Radioactive water found outside building suggests probable meltdown

Reactor 3: Crack seen down side of primary containment

Reactor core: Partial meltdown likely. This reactor uses mixture of uranium and plutonium. Plutonium found in soil at five places around plant

Reactor 4: Shutdown before earthquake. Spent fuel rods overheat causing explosion and release of radioactive steam on March 15. **Danger of spent fuel rods cracking open, causing large-scale release of radiation**

Reactor 5, 6: Shut before earthquake. **Power restored to cooling system of spent fuel storage pool**
