# Derailed U.S. train took bend too fast

An Amtrak train that derailed in Washington state was travelling at 130km/h in a 50km/h zone when it plunged off a bridge onto a busy highway, killing at least three people and injuring more than 100

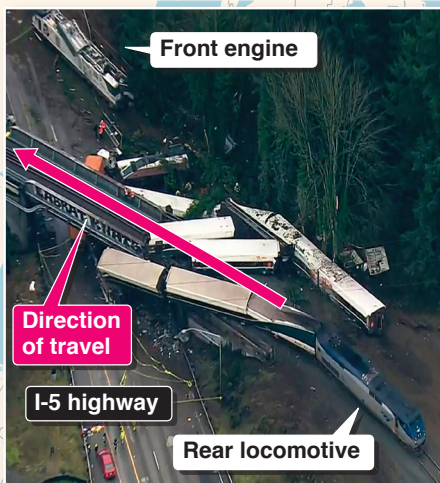
06:00 local time  
(14:00GMT):  
Train 501 leaves  
Seattle, heading  
for Portland

*Train was on inaugural  
run on new, shorter,  
high-speed route*

7:34: Train derails.  
**Positive Train Control (PTC)** –  
safety system that automatically  
warns driver of speed limits and  
applies brakes if warnings are  
not heeded – not operational
