Key bolts missing from Alaska Airlines plane

A door that blew off an Alaska Airlines Boeing 737 MAX 9 jet shortly after take-off may not have been properly secured, according to accident investigators

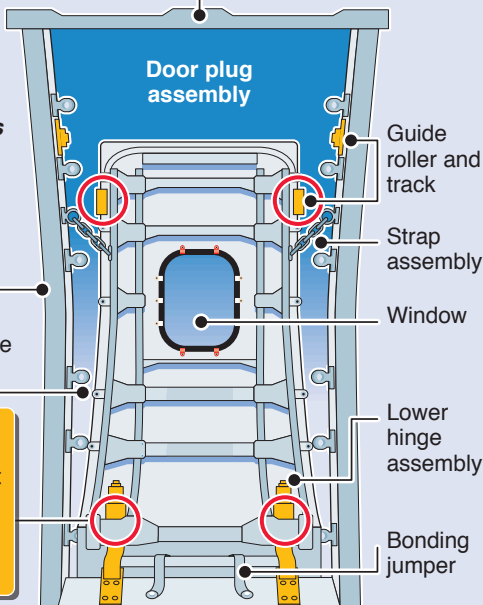
MID-EXIT DOOR PLUG

Panel seals door opening that is not used by most airlines

Door frame: Plug secured to frame with bolts, stop pads and straps

Stop pads and fittings

Six pairs on each side of frame and door plug

Bolts: Investigators say evidence from fuselage and recovered door indicates that four bolts "were missing". This would allow panel to slide upward and detach from stop pads
